Torsional vibration problems with a synchronous motor

by Peyton Swan, P.E. Sr. Machinery Diagnostic Services Engineer Bently Nevada Corporation

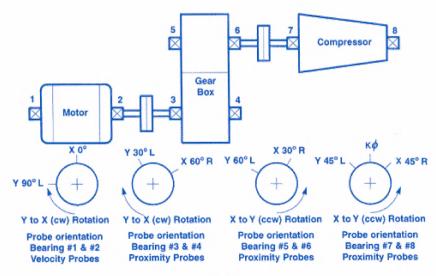
Figure 1

Machine train diagram showing the transducer locations.

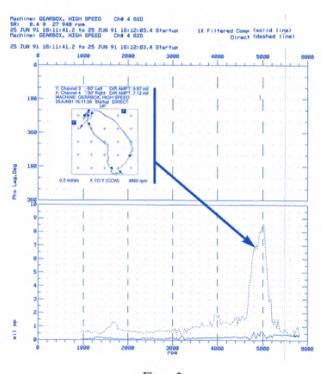
Figure 2
Two types of transient startup data:

(1) The solid lines in the upper and lower rectangles are a Bode plot of 1X vibration. The upper rectangle shows little phase information because, at most speeds, the 1X amplitude was lower than the ADRE 3 System's threshold for processing phase information.

(2) The dashed line in the lower rectangle is an amplitude versus speed plot of direct (unfiltered) vibration. It has no corresponding phase information because it is not a filtered signal.

(3) An orbit plot has been superimposed to show what the orbit would look like at approximately 4900 rpm.

of direct vibration. It has no corresponding phase information because it is not a filtered signal. The dashed line shows that direct vibration amplitude was low at all speeds, except for a narrow range centered at approximately 4900 rpm. Vibration increased rapidly at that speed, and peaked at approximately 216 μm (8.5 mils) pp. It was as though the rotor had passed through a lateral rotor resonance. However, it was not a 1X balance resonance, because its characteristic, a peak in amplitude accompanied by a 90° phase change, was not present in the 1X Bode plot.

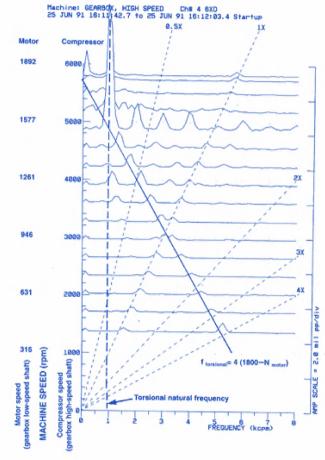
Figure 3

Spectrum cascade plot of vibration on the high-speed shaft, from vibration acquired at startup from proximity transducers mounted at bearing #6. The two vertical scales on the left side are related by a factor of 3.17, the gear ratio of the speed-increasing gearbox.

It was clear that the machine's vibration response was at frequencies other than running speed. To identify those frequencies, we examined a spectrum cascade plot of the same data (Figure 3). A spectrum cascade plot is a series of spectrum plots, each of which corresponds to a different shaft speed. Two distinct vibration components are evident. The first is the 1X vibration component. It is typical of the 1X component in most spectrum cascade plots of rotating machinery data. Its positive slope indicates that its frequency increases with the speed of the motor.

The second vibration component is not typical. It has a negative slope, which indicates that its frequency decreases as the rotor speed increases. If the line were extrapolated, the component would have a frequency of 7200 cpm when the motor was first started up. As the motor increases speed, the component's frequency decreases, in inverse proportion to motor speed. The component's amplitude peaks when the motor speed is just above 1500 rpm (and the high-speed rotor reaches 4900 rpm). At that point, its frequency is just above 1500 cpm. Its frequency continues to decrease, until it is 0 cpm when the motor speed reaches 1800 rpm.

This equation defines a torsional vibration with a frequency that decreases as motor speed increases. At operating speed, the oscillating component disappears. It also explains the frequency of the unusual vibration component in the cascade plot (Figure 3).
